# Rayong Electricity Generating Co.,Ltd. (REGCO)

18 February 2005

# REGCO CASES' APPLICATION FOR PROCESS-IT

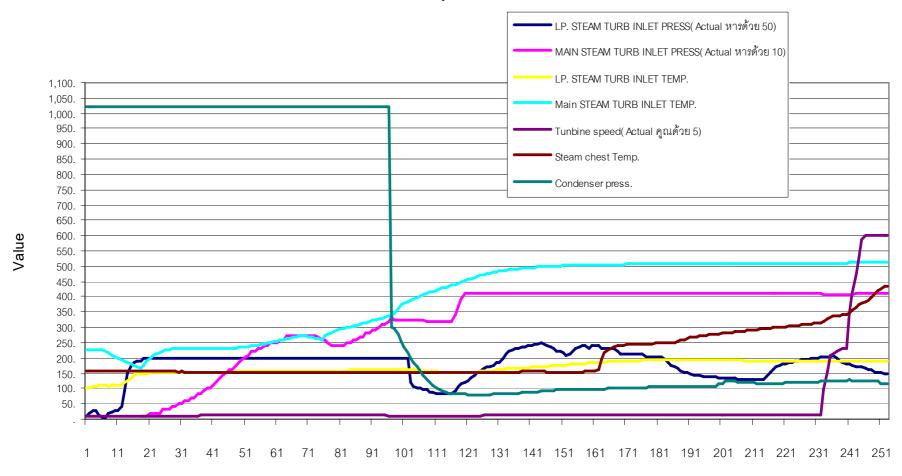
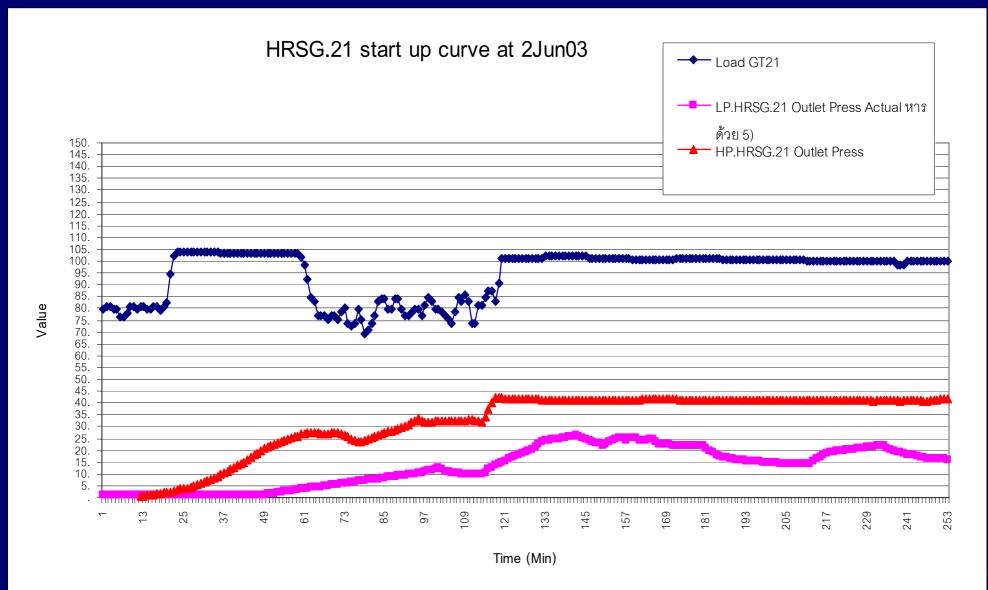
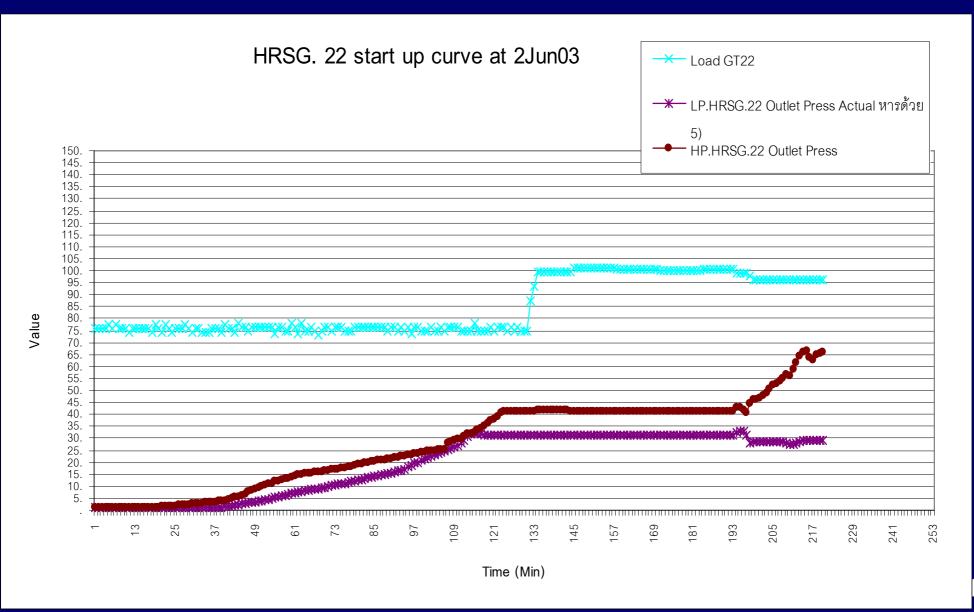
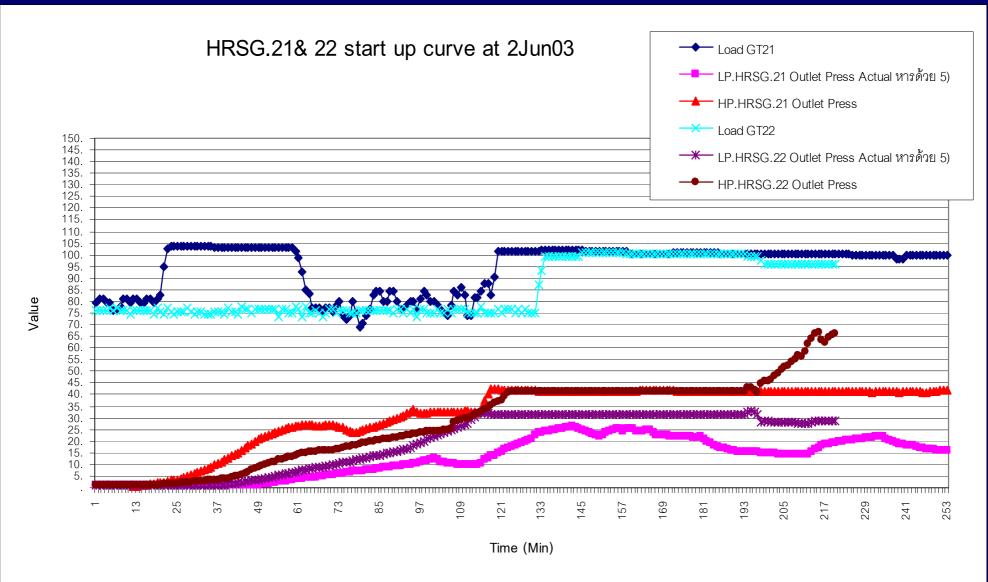
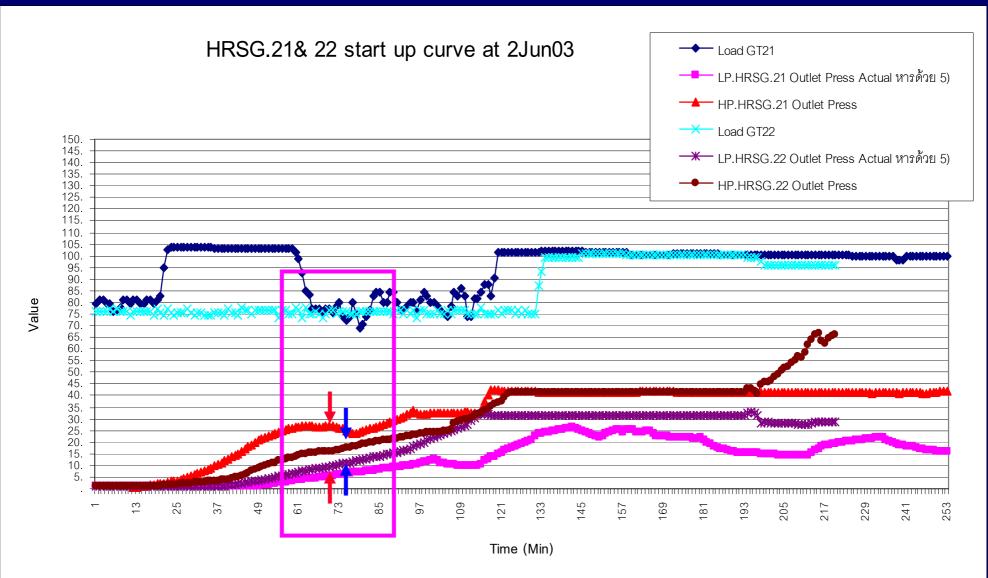
#### ST.20 start up curve at 2Jun03

- HP Pressure for HRSG-21 increases faster than HRSG-22, but LP Pressure for HRSG-21 increases slower than HRSG-22 at same load.
- Possible cause: HP water flow for HRSG-21 is higher than normal and causes heat absorption from exhaust gas instead of LP water flow.
- Different water flow from design But How?

- LP Eco. Coil problems
- LP Circulation Pump problems
- HP Economizer Recirculation valve is not working properly
  - "After testing of HP Economizer Recirculation valve, this valve is not operated as designed (full open during start-up) and cause changing of HP and LP flow."

"The compress air supply for this ACV is closed manually"

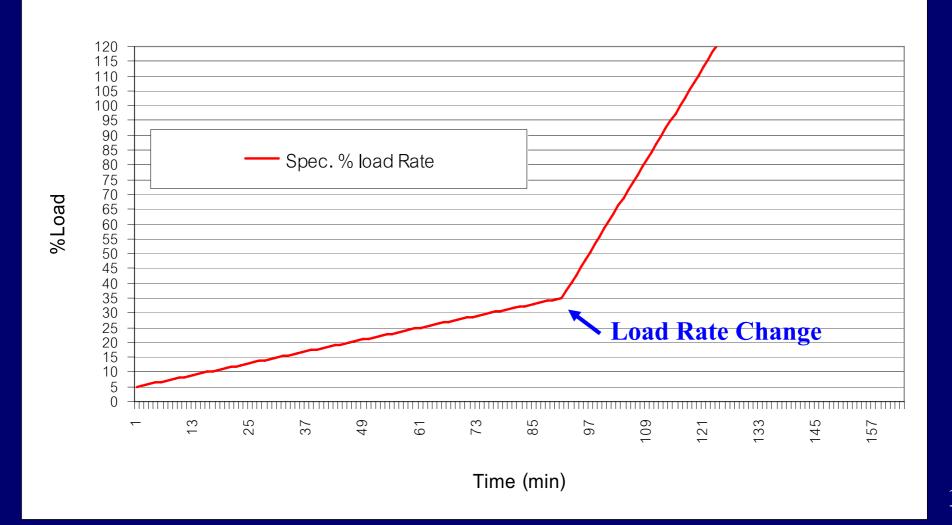
Steam Turbine Start-up Curve(Cold)

- Steam Turbines are controlled by EHC for start-up, shutdown, loading, and protective devices.
- REGCO's steam turbines are designed for 3 start-up modes; Cold, Warm, and Hot.
- For Cold Start-up Mode (casing temp. below 330°C), Steam Turbine is started and loaded with 2 load-rate, 0.333%/min when load is less than 35%, and 2.60%/min when load is higher than 35%)

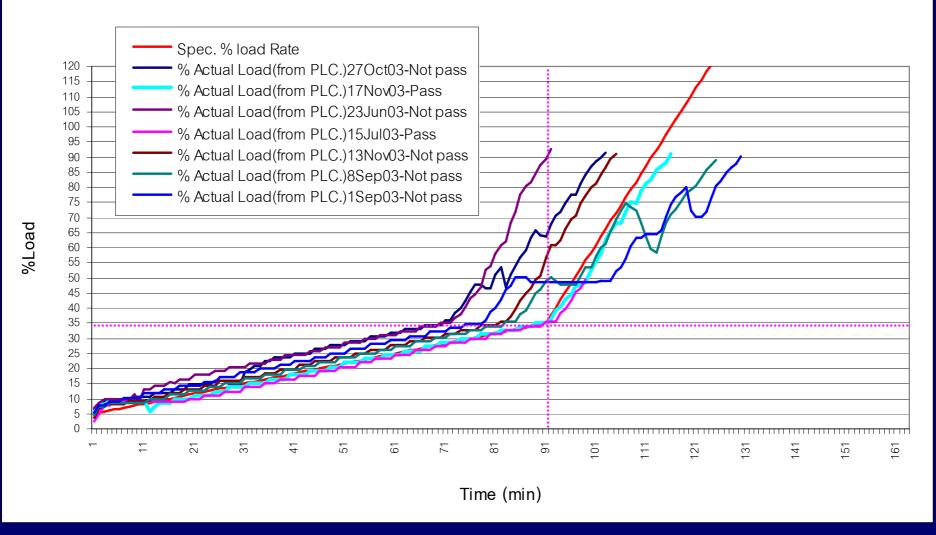
#### Trend Load ST.40(Cold) Y2003

- Process-IT Data(23 Jun 17 Nov 2003), were shown that ST-40 were started 7 times with designed load rate only 2 times, while 5 times of start-up were faster than design curve.
- The problems were caused by prior command from EHC to change load-rate from 0.333%/min to 2.6%/min before 35% load.
  - "After EHC checking, EHC was found that command signal was not stable and caused prior command. EHC Card was changed"
