# Rayong Electricity Generating Co.,Ltd. (REGCO)

18 February 2005

# REGCO CASES' APPLICATION FOR PROCESS-IT

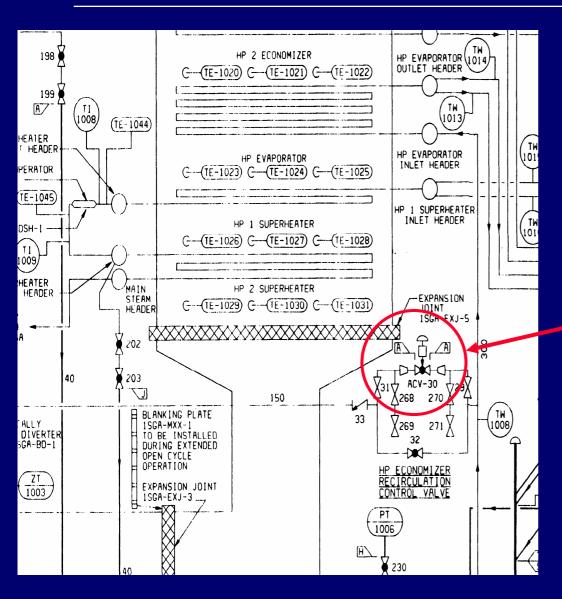
- HP Pressure for HRSG-21 increases faster than HRSG-22, but LP Pressure for HRSG-21 increases slower than HRSG-22 at same load.
- Possible cause: HP water flow for HRSG-21 is higher than normal and causes heat absorption from exhaust gas instead of LP water flow.
- Different water flow from design But How?

#### **Possible Cause for Flow changes**

- LP Eco. Coil problems
- LP Circulation Pump problems
- HP Economizer Recirculation valve is not working properly
  - "After testing of HP Economizer Recirculation valve, this valve is not operated as designed (full open during start-up) and cause changing of HP and LP flow."

"The compress air supply for this ACV is closed manually"
